St. Anthony Mobile Home Park
67-075 Highway 111 ❖ Mecca, CA 92254
Drinking Water Assessment Final Report ❖ January 21, 2010

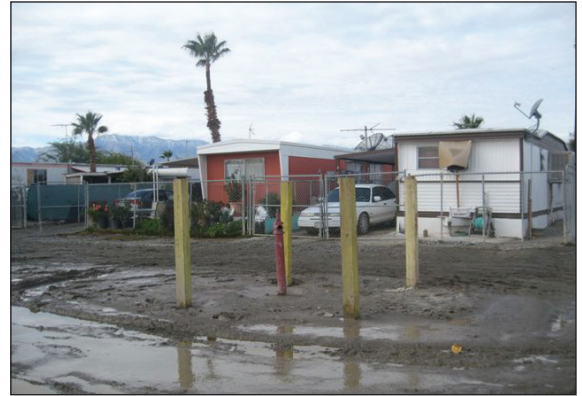
The water system consists of one drinking water well, one hydro-pneumatic tank, and a grid/branch style distribution system. In addition, there are four centralized drinking water tanks that are filled by hauling water using various trucking services located in the Coachella Valley. This provides the residents with a safe supply of drinking water, rather than the tap water that exceeds the maximum contaminant level (MCL) for arsenic.

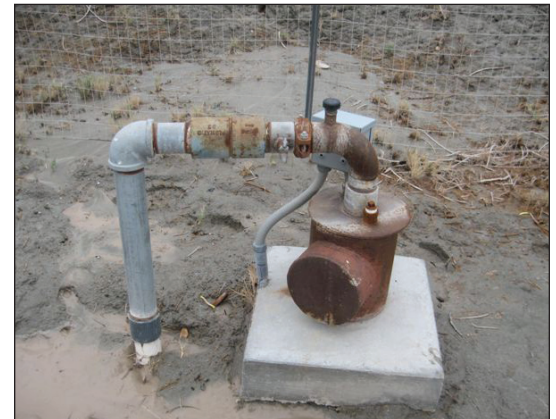
The well site is poorly fenced but receives some protection from contamination due to its isolation and distance from passing vehicles and any solid waste. A poorly fenced well site is vulnerable to vandalism. The well site itself, along with many of the homes, are located in low parts of the valley which makes the well vulnerable to flash flooding.

The well site is poorly fenced and is vulnerable to vandalism.

- The well and its equipment are not fenced in properly, leaving it vulnerable to vandalism or damage. The well equipment could be damaged or adjusted without warning, threatening the community's water supply.

- Have the barrier replaced or repaired around the well and its equipment to protect it from vandalism and damage. This would better protect the community's water supply from being tampered with.

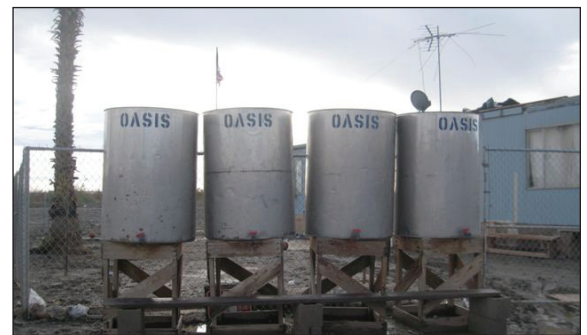
There are no procedures for disinfection or sampling for bacteriological contamination of the drinking water tanks.

There currently is no defined maintenance program for maintaining sanitary conditions of the centralized drinking water tanks. The tanks are cleaned periodically and filled approximately every couple of days. There are no procedures for disinfection or sampling for bacteriological contamination of the tanks.

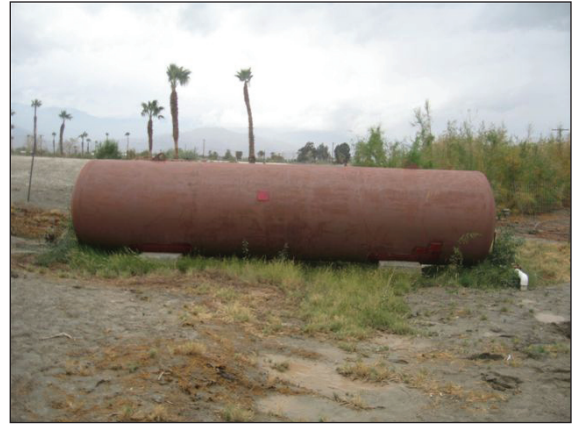
The St. Anthony water system uses one steel hydro-pneumatic pressure tank. The installation date is unknown. The hydro-pneumatic tank is designed to provide adequate pressure to the distribution system without causing the pump to cycle continuously. The total volume of the pressure tank is approximately 3,000 gallons and is old, but in fair condition. The pressure is maintained between 40 to 60 psi. The system requires the operator to bring in an air compressor to recharge tank pressure. The tank does not have a level indicator to indicate the amount water/air ratio. The tank is equipped with a pressure relief valve. This valve protects the water distribution system from damage due to high pressure situations. The tank is also equipped with a drain valve which allows the tank to be drained for maintenance or repairs. The last date of tank maintenance or cleaning is unknown.

- The water-to-air ratio in the hydro-pneumatic tank was unknown. This could lead to a low air level, which could lead to system damage without air available to protect the system against water hammer.

- Install a sight tube on the tank, or use any other available methods to determine the water to air ratio within the tank. If the air level is low, use an air compressor to add air.
